## MEMORANDUM

SUBJECT: **95 Express Phase 1 (Segments 1N and 1S) ELM Performance Update (Through May 2018)**

DATE: July 31, 2018

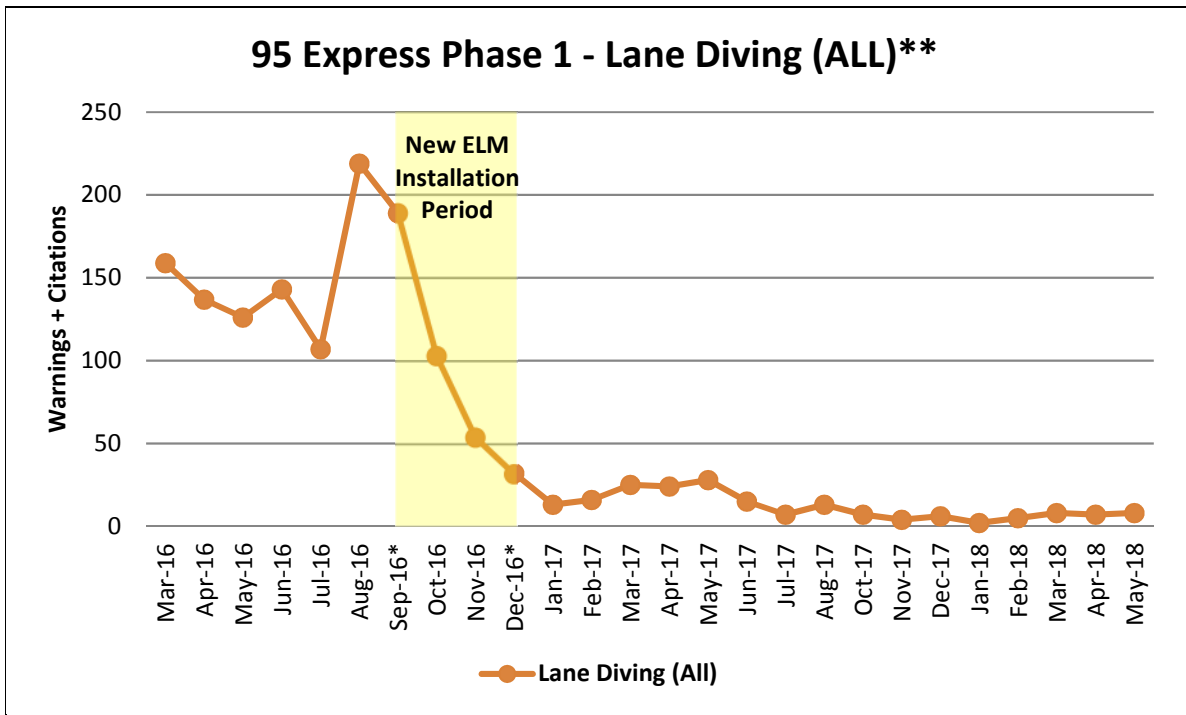
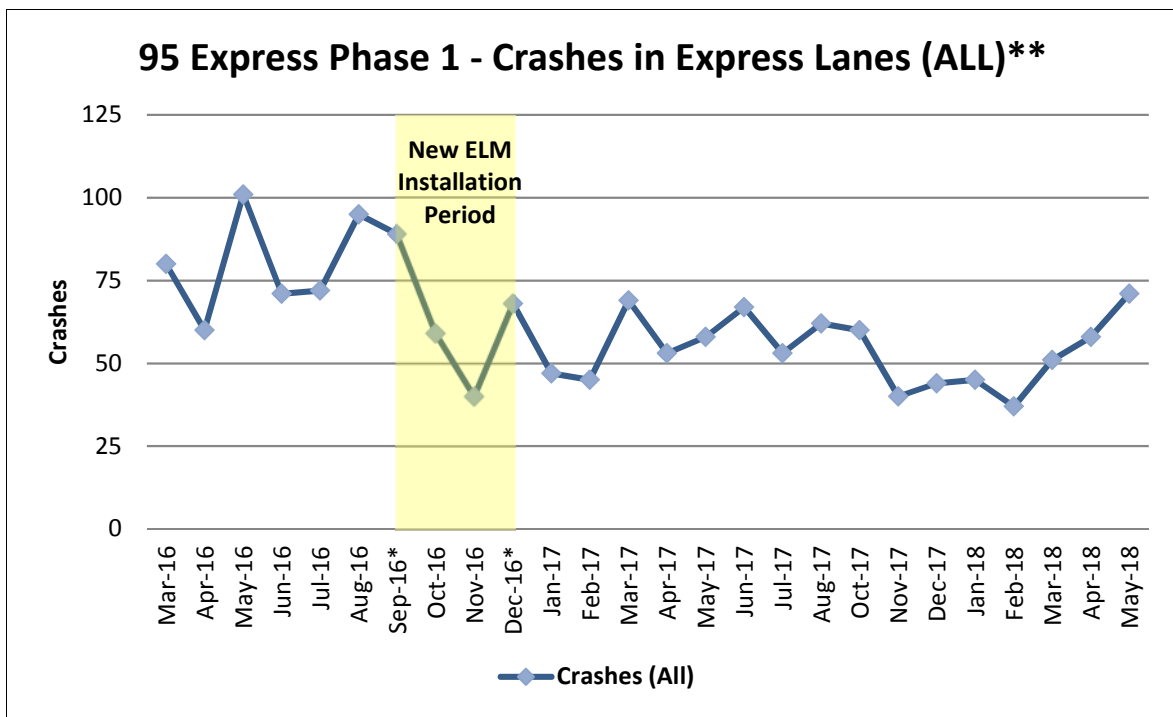
Graphs showing the positive trends for lane diving and crashes in the express lanes are shown on the following page.

\*\* Disclaimer: Data for September 2017 are not included due to the impact of Hurricane Irma.

Through May 2018, the new ELM installation has contributed to the following average monthly improvements for 95 Express Phase 1:

- \* ELM Replacement is down 92%;
- \* Lane Diving is down 92%;
- \* Crashes within the facility are down 34%; and,
- \* Express Lanes volume has decreased by 0.3%.
